## Reference study

### HYDRAULIC SYSTEM

Hydraulic machine for cutting of transformer steel sheets  
Fabricate: Heinrich Georg GmbH  
Build Year: 1992  
Oil volume: 1300 ltr. Mobil, NUTO HP 46 cSt oil.

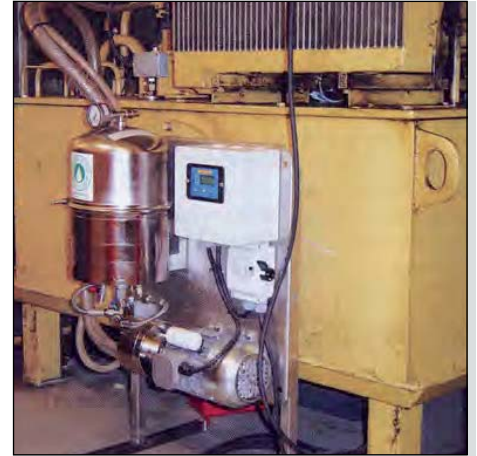
The 1300ltrs. oilreservoir, here shown with a Europafilter cleaner assembled. The filter cleans in a kidney loop.

A standard Europafilter offline oil-cleaner unit, with only one filter, was assembled to the oilreservoir. The oil-cleaning process proceeded continuously during full production. After a couple of days the trouble with the hydraulic system was gone and it has not appeared again since.

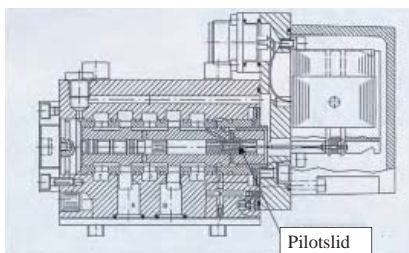
Servovalve of Schneider fabricate. A Brow/black coating was observed on the pilotslid. This sticky coating made the pilotslid lock in the valve circuit.

Coating on the pilotslid caused trouble with operational reliability on the transformer sheet cutter. A brow, black and sticky coating caused the valve to hang and malfunction. A service man from Heinrich Georg GmbH was contacted and he trimmed the system but the trouble continued. The hydraulic oil was changed but the problems still continued...
